## Appendix E

### Photographic Log

## Appendix E - Pollution Prevention Photographic Log

**CLIENT:** Invista

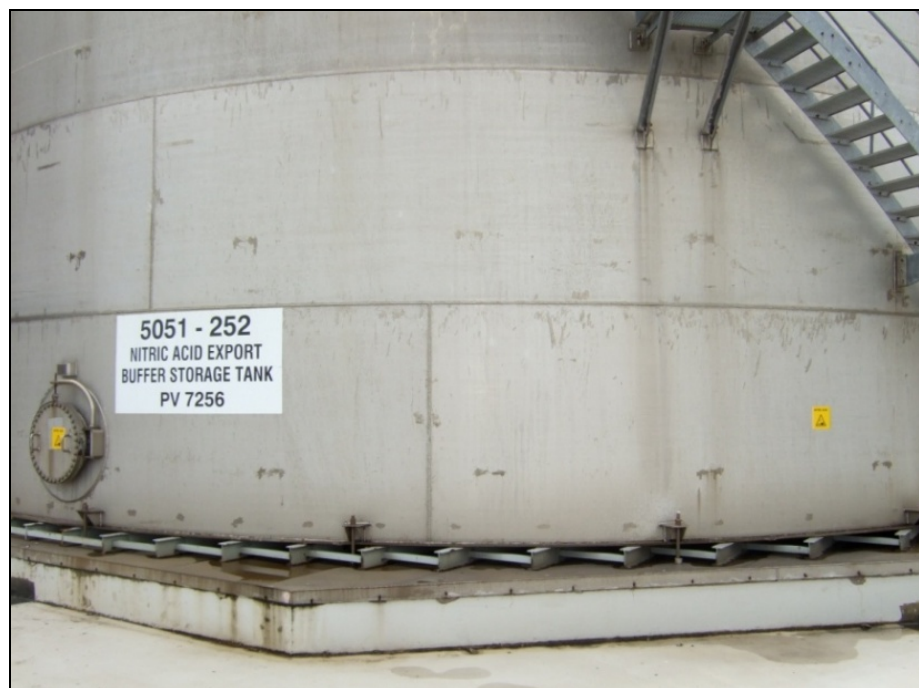
**PHOTOGRAPH #:** 2

Tanks were designed to facilitate visual detection of leaks. Most tanks were constructed on plinths with a clear break between the base of the tank and the top of the plinth.

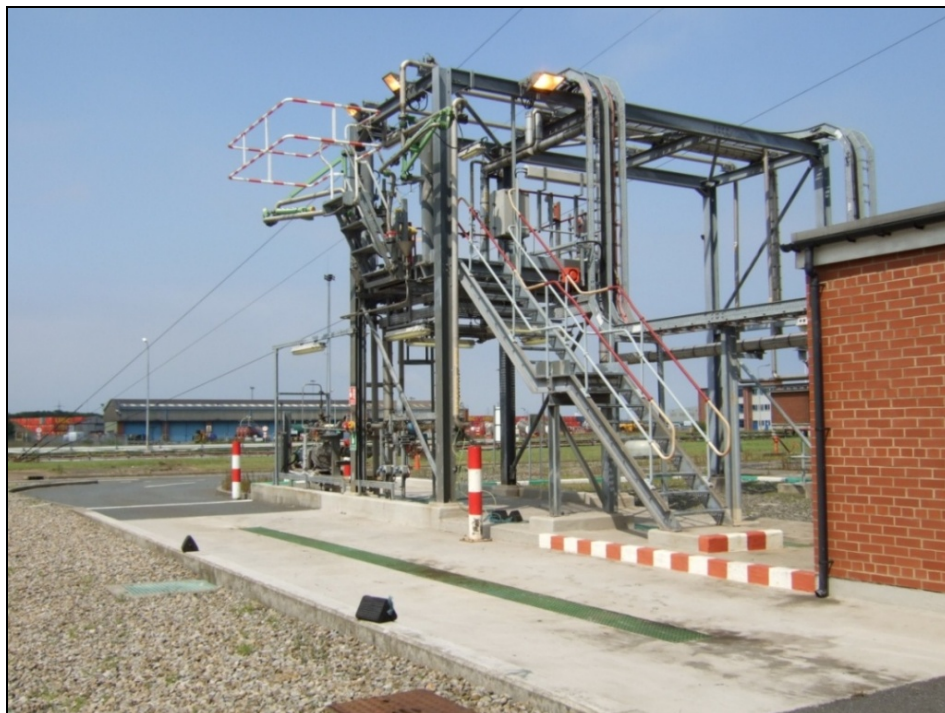
**PHOTOGRAPH #:** 3

Chemical transfers were carried out in contained zones with drains leading to containment sumps.

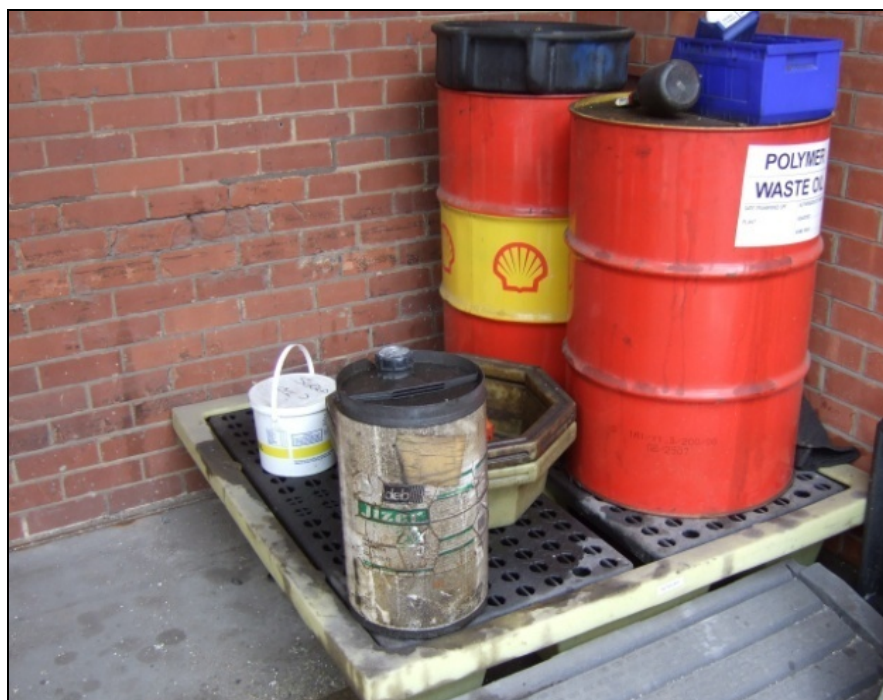
**PHOTOGRAPH #:** 4

Containment for drum storage.

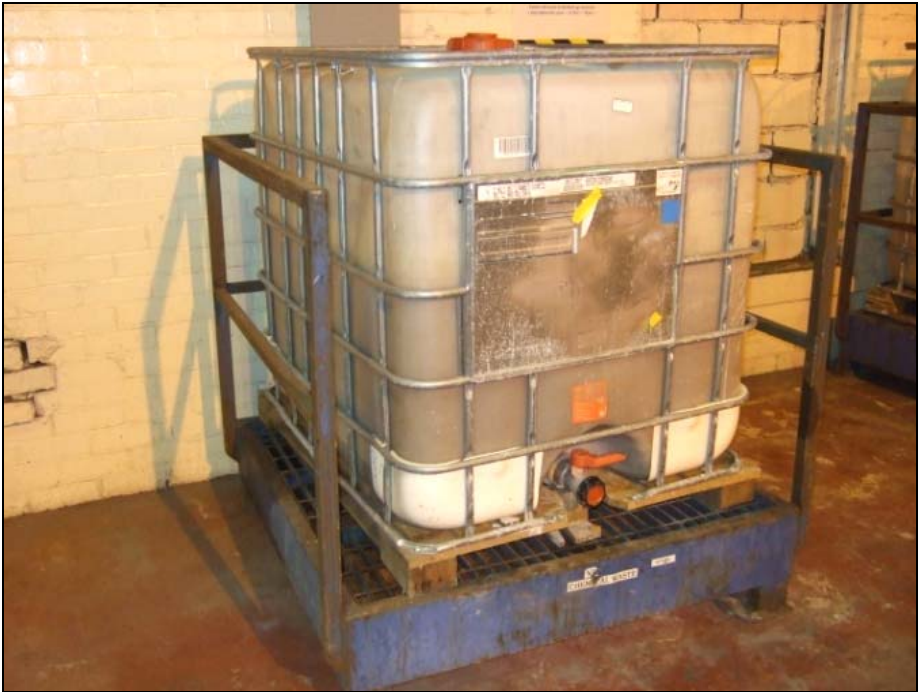
| <b>PHOTOGRAPH #:</b> 5 | |

| <b>COMMENT:</b><br><br><br><br><br><br><br><br><br><br>Containment for IBC – note plug in discharge line. | |

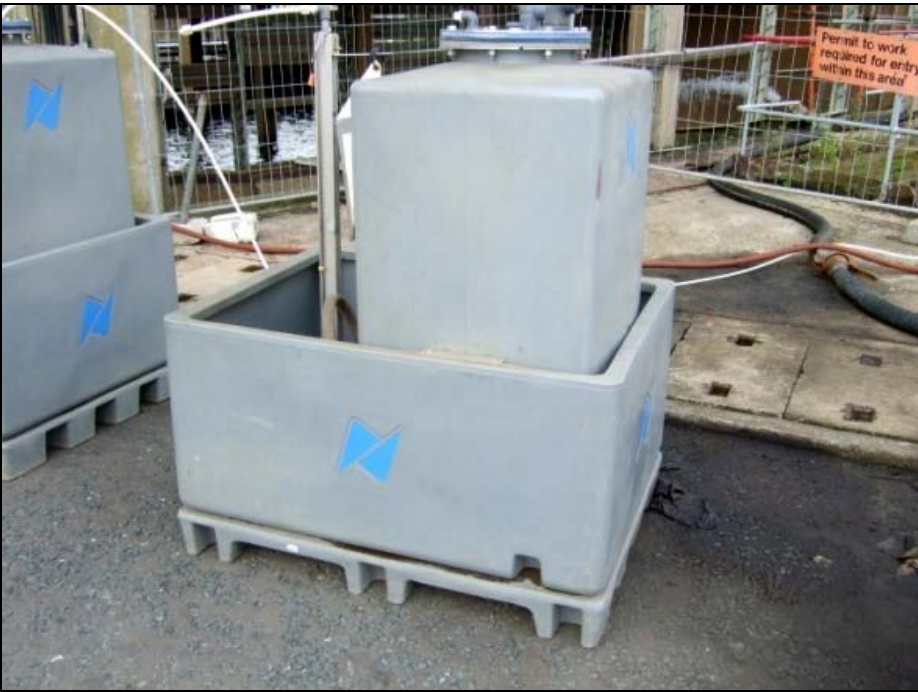
| <b>PHOTOGRAPH #:</b> 6 | |

| <b>COMMENT:</b><br><br><br><br><br><br><br><br><br><br>Water treatment chemicals were stored in double skinned containers as shown. | |

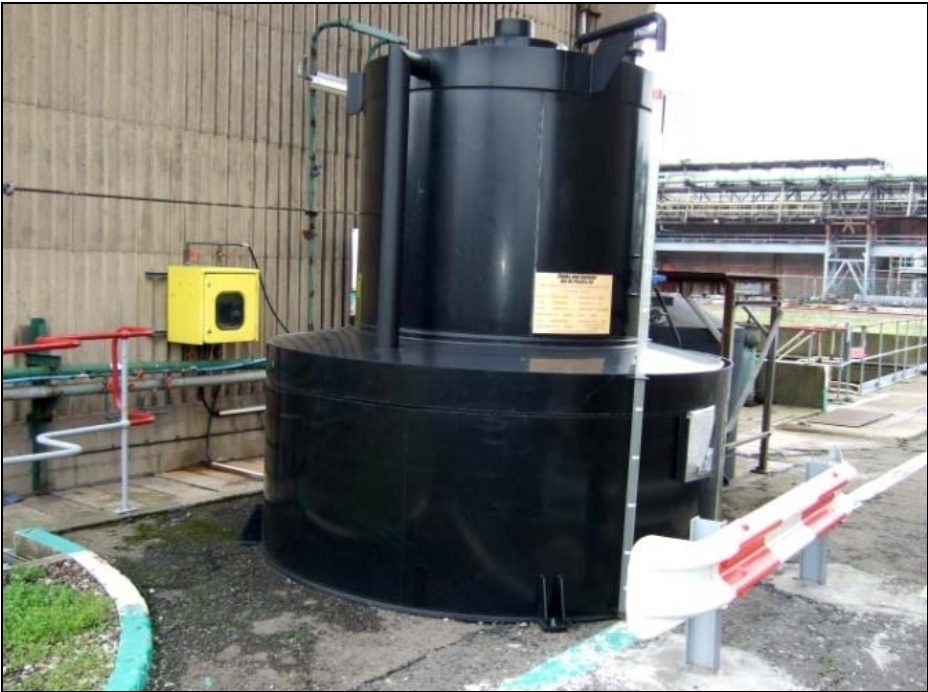
| <b>PHOTOGRAPH #:</b> 7 | |

| <b>COMMENT:</b><br><br>Water treatment chemicals stored in double skinned containers. | |

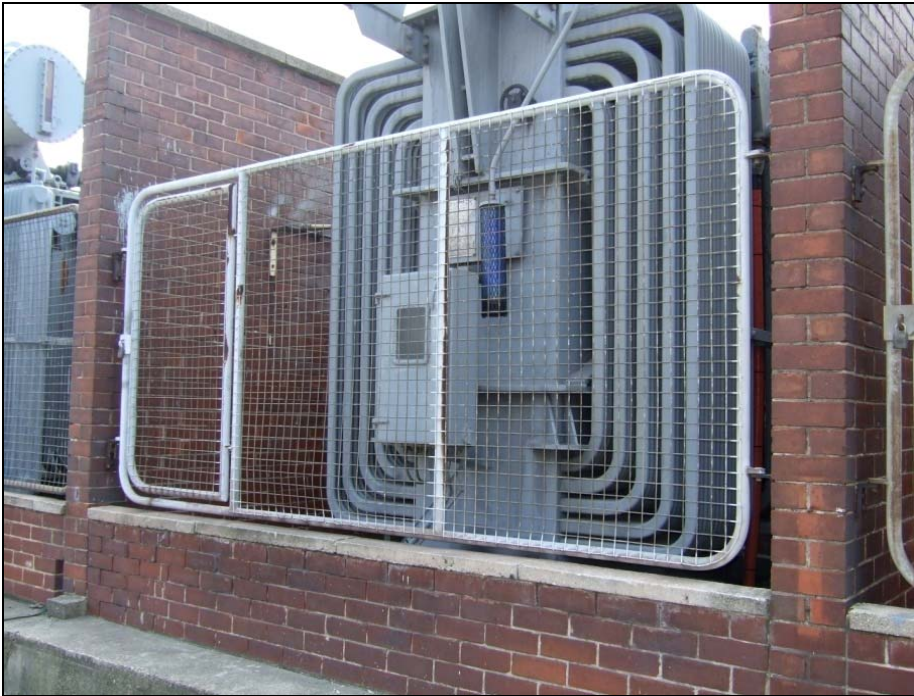
| <b>PHOTOGRAPH #:</b> 8 | |

| <b>COMMENT:</b><br><br>Transformers located in secure bunded compound | |
