### Remediation of BH304

**Remediation of BH304**  
**INVISTA Wilton**  
**INVISTA Textiles (UK) Ltd**  
**P.O. Box 401**  
**Wilton**  
**Redcar**  
**TS10 4XY**

**September 2010**  
**960100403**

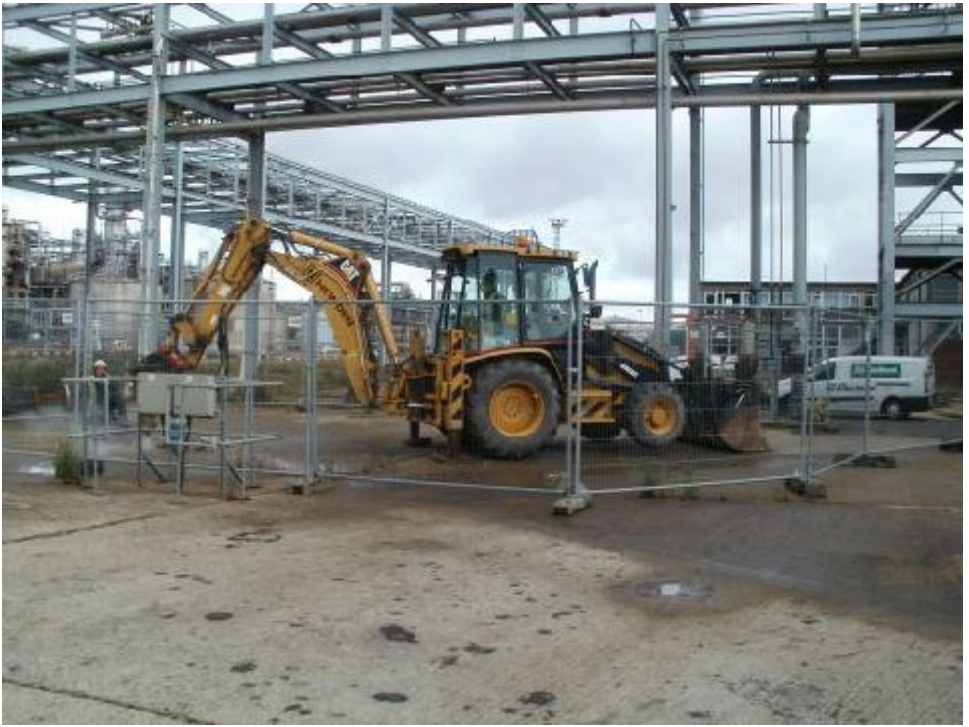
| <b>PHOTOGRAPH #:</b> 1 | |

| <b>COMMENT:</b><br><br><br><br><br><br><br><br><br><br>Mesh panel HERAS fencing was used to define the excavation area. | |

The excavation area was separated from the site using mesh panel HERAS fencing (Photo 1, Appendix A).

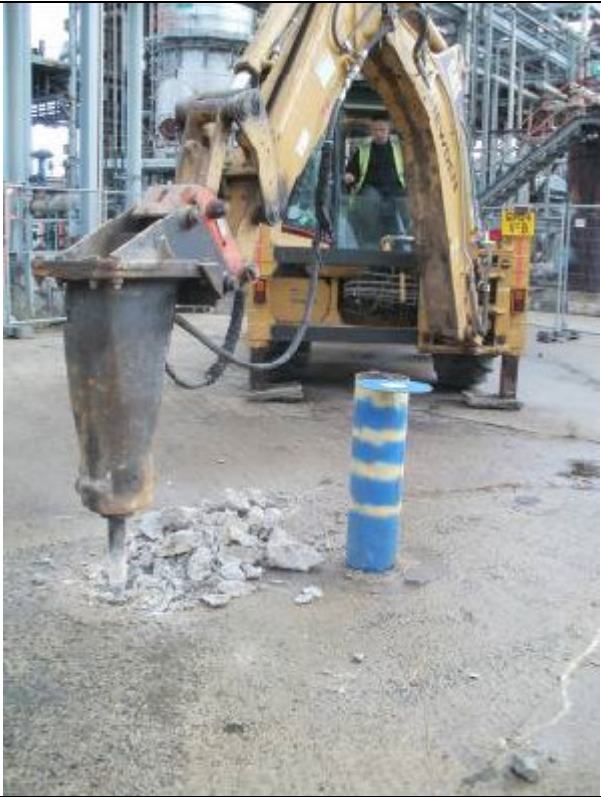
| <b>PHOTOGRAPH #:</b> 2 | |

| <b>COMMENT:</b><br><br><br><br><br><br><br><br><br><br>Breaking the concrete using a hydraulic hammer. BH304 was at the centre of the excavation area. | |

Excavation works took place on 17<sup>th</sup> August 2010 using a Backhoe Excavator. A 2m<sup>2</sup> area of concrete (centred over BH304) was broken out using a hydraulic hammer (Photo 2, Appendix A). The concrete was visually inspected and deemed suitable for re-use as backfill.

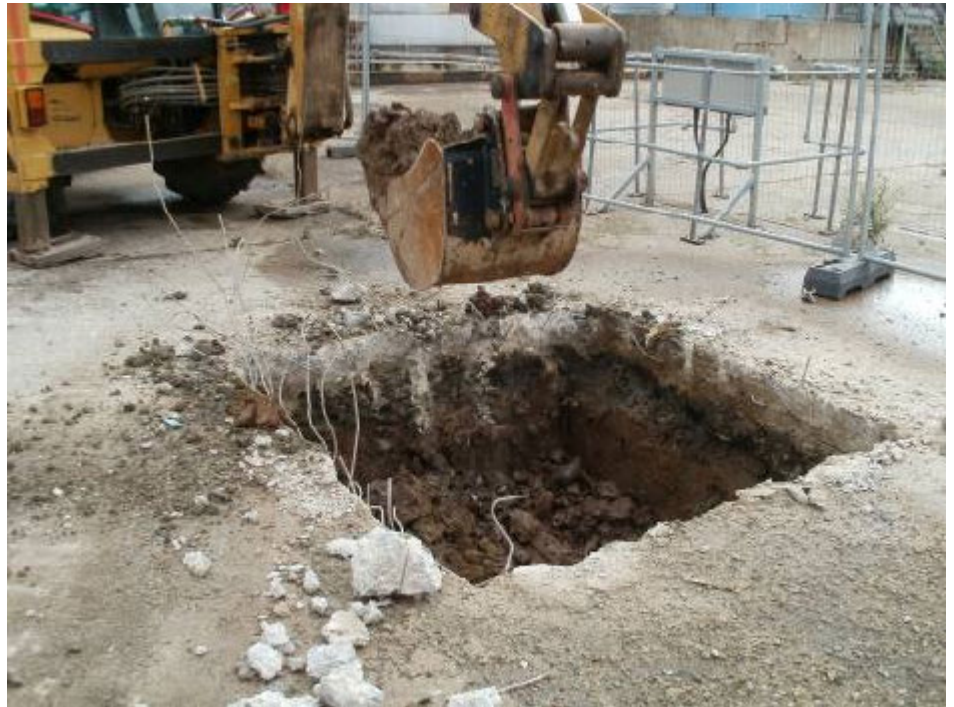
**PHOTOGRAPH #:** 3

Extent of remedial excavation area.

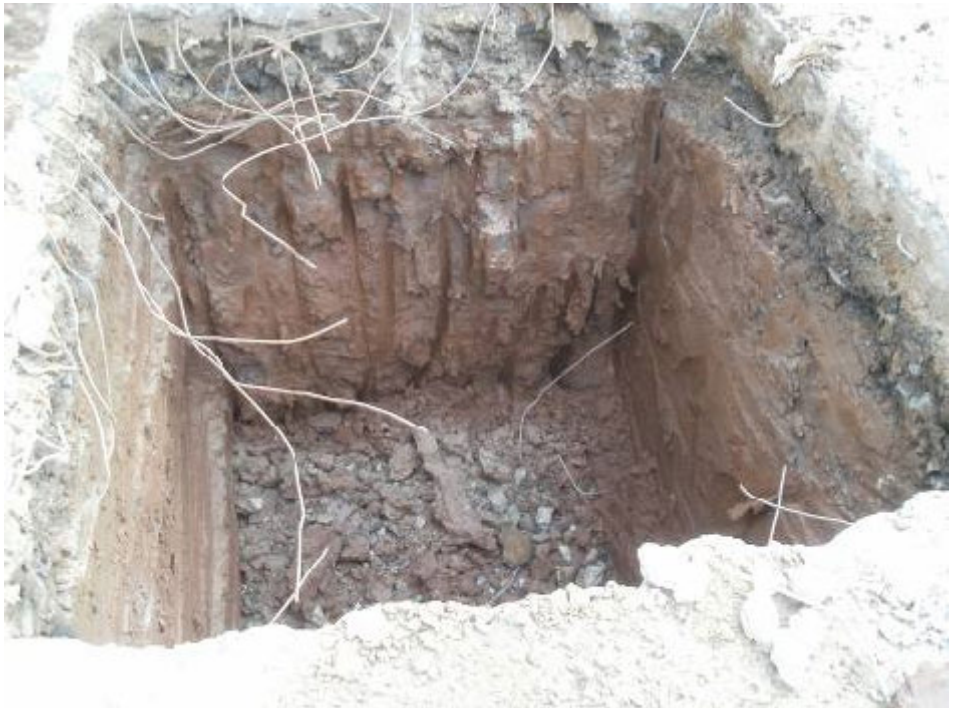
**PHOTOGRAPH #:** 4

Completed remedial excavation.

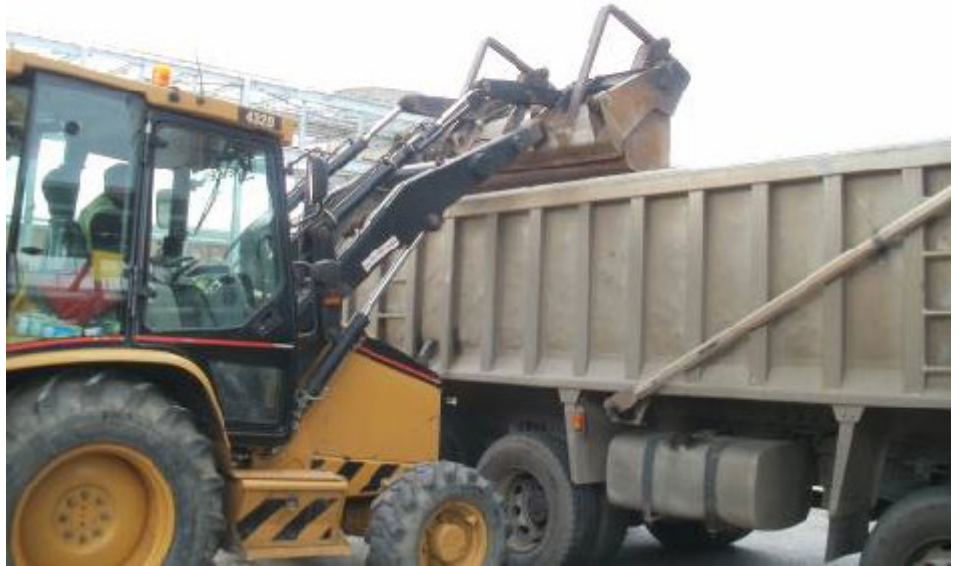
**PHOTOGRAPH #:** 5

Loading materials from excavation.

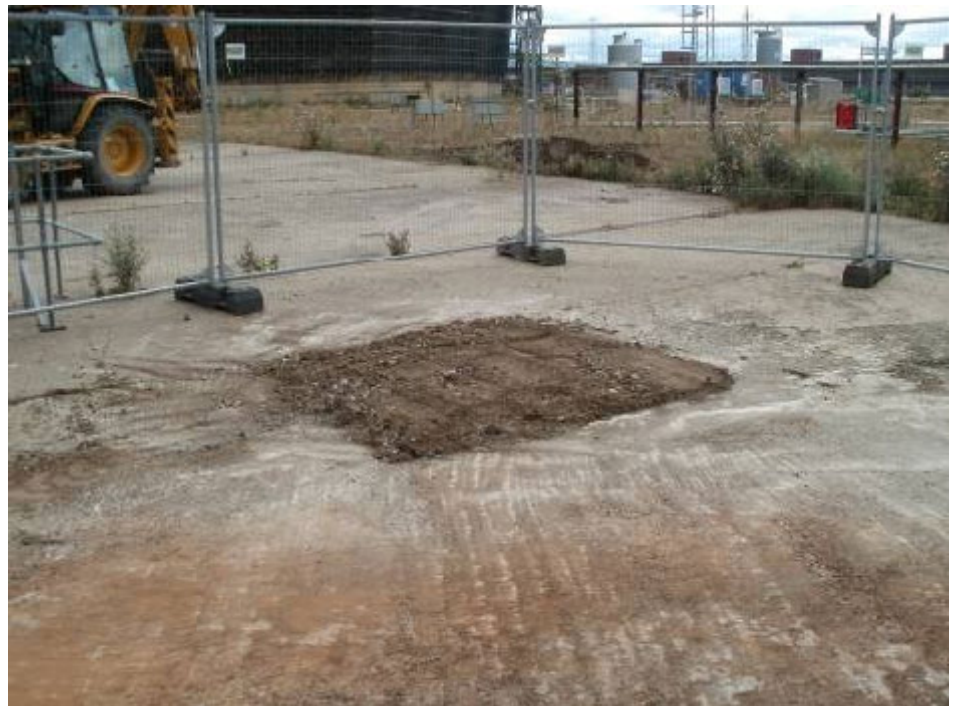
**PHOTOGRAPH #:** 6

Completed remedial works.
